# Manhole Inspection Summary

Manhole # S15YY\_002MH

Insp Date: **4/6/07 9:06 AM**

**Location** Address: **3301 REISTERSTOWN RD**

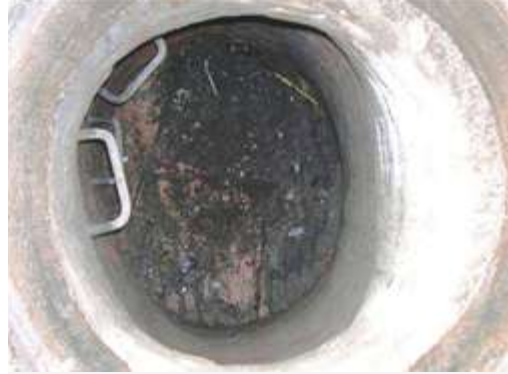
Top View

Channel debris.

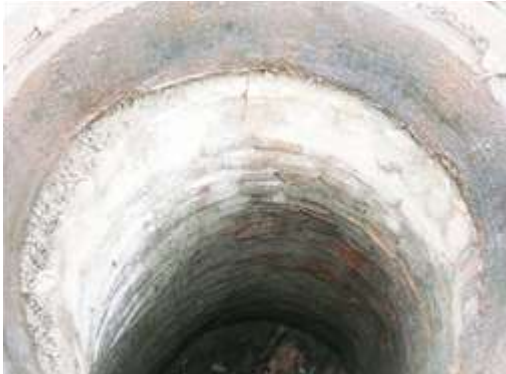
Defect

Frame leaks. Frame offset. Adjustment and Barrel infiltration - other side.

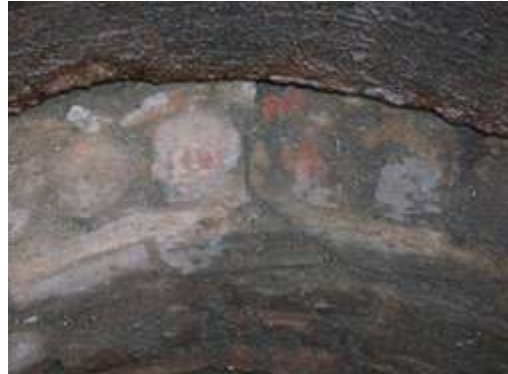
Defect

Adjustment cracks and infiltration.

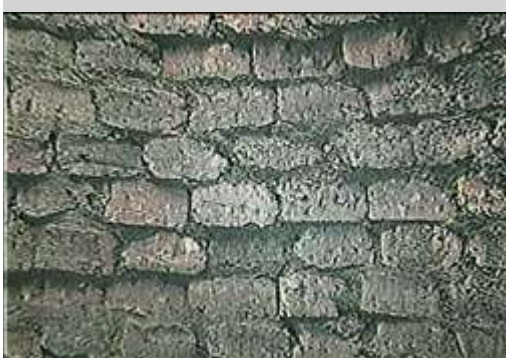
Defect

Barrel deterioration and infiltration.

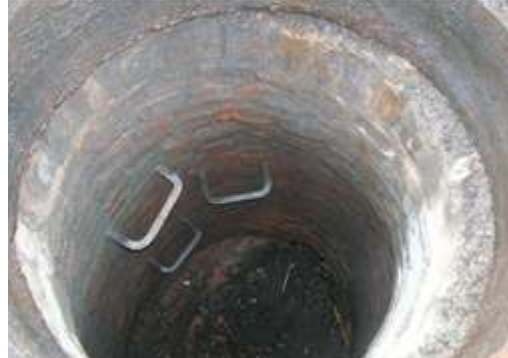
Defect

Frame leaks. Frame offset. Adjustment and Barrel infiltration.

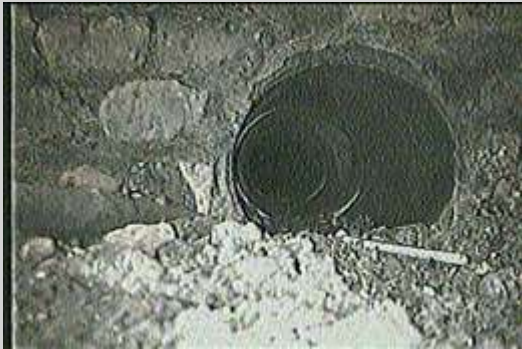
8 in. Circular Gravity Sewer  
Pipe Out @ 12 O'Clock

Deposits: ☐ None ☒ **Mud** ☐ Sludge ☒ **Debris** ☐ Grease

Silt Depth: **0.5** (in.) Deposits Extent: **Light**

Infiltration: **Evidence** Pipe Seal Cond: **Unknown**
